# Manhole Inspection Summary

Manhole # S37A\_\_018MH

Insp Date: **8/25/08 11:34 AM**

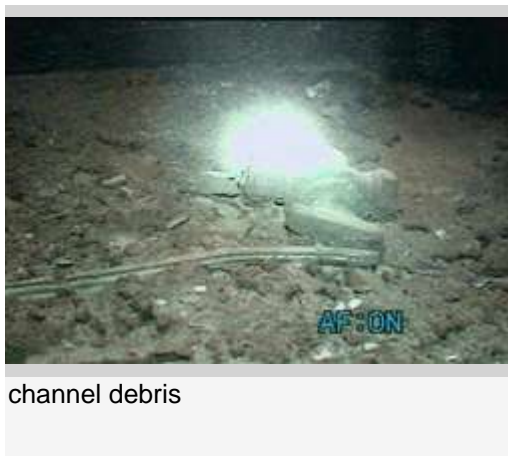
Defect 3

Condition: ☐ Sound ☐ Cracked ☐ Root Intrusion ☐ Deteriorated ☐ Leaks ☒ **Debris**

channel debris

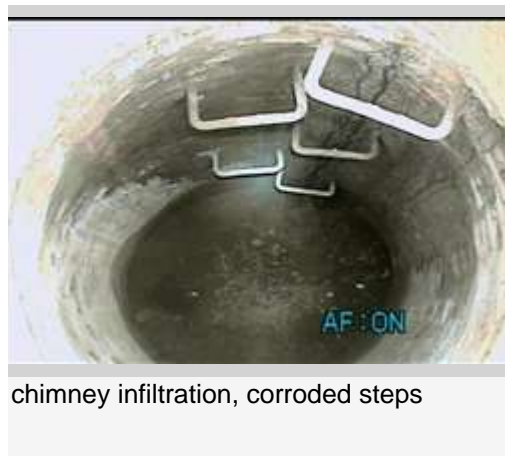
Defect 2

Infiltration: ☐ None ☐ Joint ☐ Cracks ☐ Mortar ☐ Roots ☒ **Wall**

Count: **5** Missing: **0** ☒ **Corroded**

chimney infiltration, corroded steps

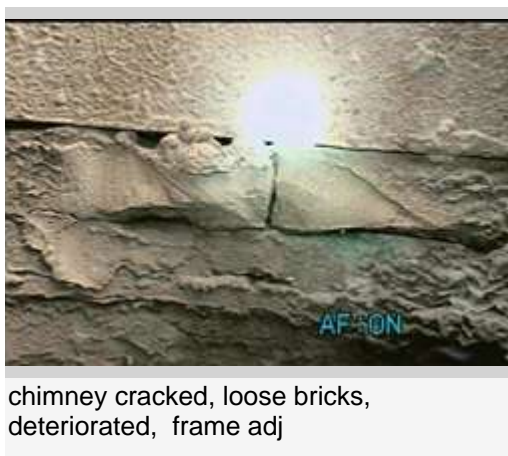
Defect 1

Condition: ☐ Sound ☒ **Cracked** ☐ Root Intrusion ☒ **Loose Brick** ☒ **Deteriorated**

chimney cracked, loose bricks,  
deteriorated, frame adj

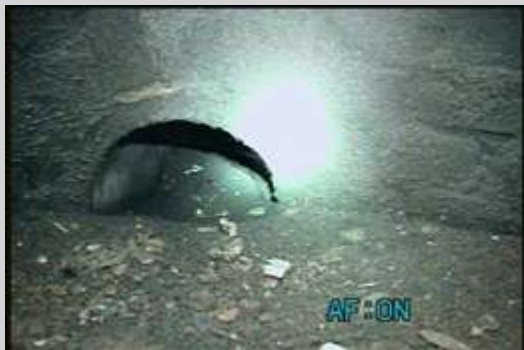
12 O'Clock Outflow

8 in. Circular Gravity Sewer  
Pipe Out @ 12 O'Clock

Deposits: ☒ None ☐ Mud ☐ Sludge ☐ Debris ☐ Grease

Infiltration: **None** Pipe Seal Cond: **Unknown**
